# Beneath the Terminal

How NIPA helps operators understand buried pipeline integrity without stopping operations

Lewis Barton | TSA Conference | Coventry | 17/09/2026

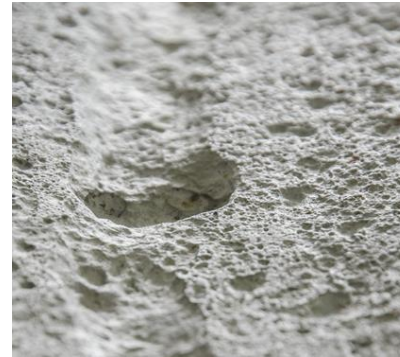
**Internal corrosion** occurs when contaminants like oxygen, CO<sub>2</sub>, H<sub>2</sub>S, chlorides, and water react with the pipeline and leads to threats such as erosion corrosion or microbiologically induced corrosion.

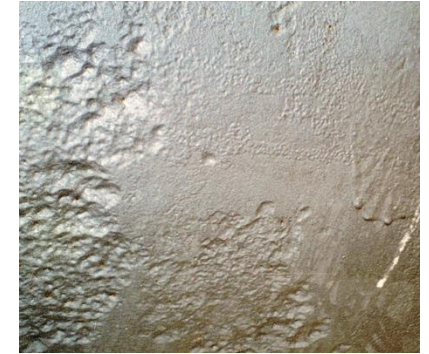
**External corrosion** is driven by environmental exposure – such as soil, moisture, and humidity – and includes threats like pitting, stress corrosion cracking, erosion, and corrosion under insulation.

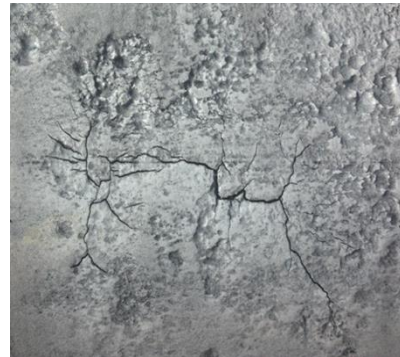
**Corrosion under insulation** occurs when moisture penetrates insulation material, leading to hidden corrosion on the underlying metal surfaces. Common in insulated piping and equipment in humid or wet environments.

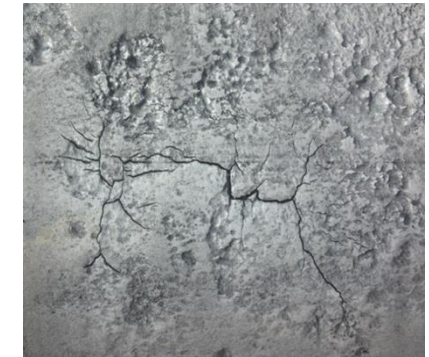
**Corrosion under pipe supports** develops at contact points between pipes and their supports, where water and debris can accumulate, creating crevice conditions that accelerate corrosion

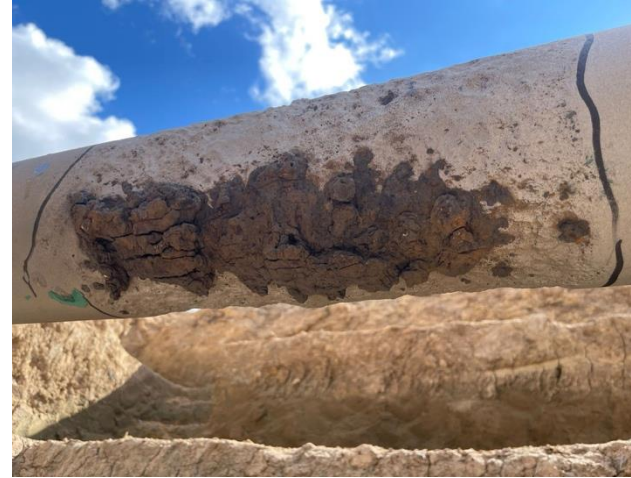
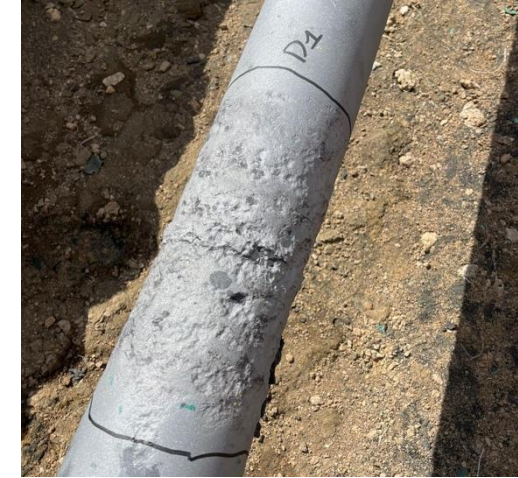
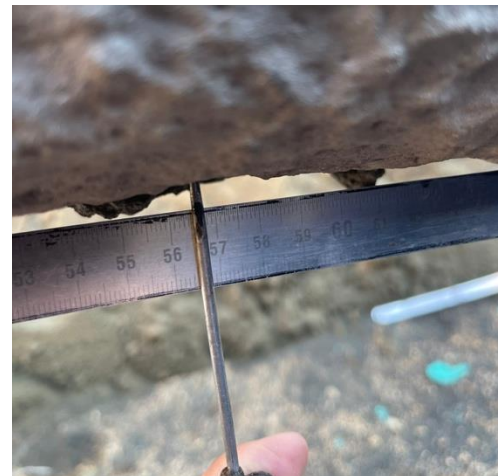
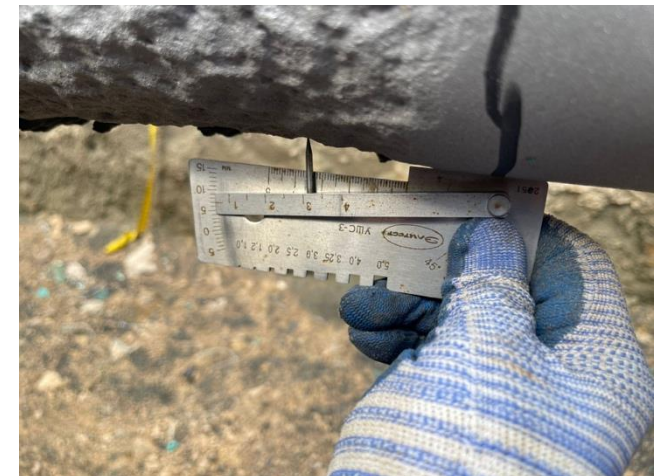
Direct examination in 2025 confirmed a **13 mm (~50% WT) metal loss defect**, matching the predictions of the integrity analytics and findings of the above ground surveys.
