Innovating tank bottom inspections with MFL Ultra sizing and machine learning

AI/ML use case

Josh Rawson | ROSEN Group | Germany | 2025

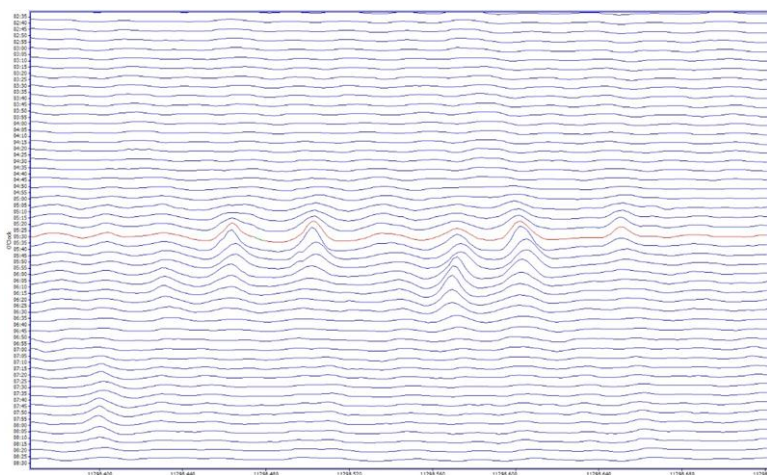
Generation of Ultra High Resolution MFL data

154

sensor channels

Traditional MFL resolution

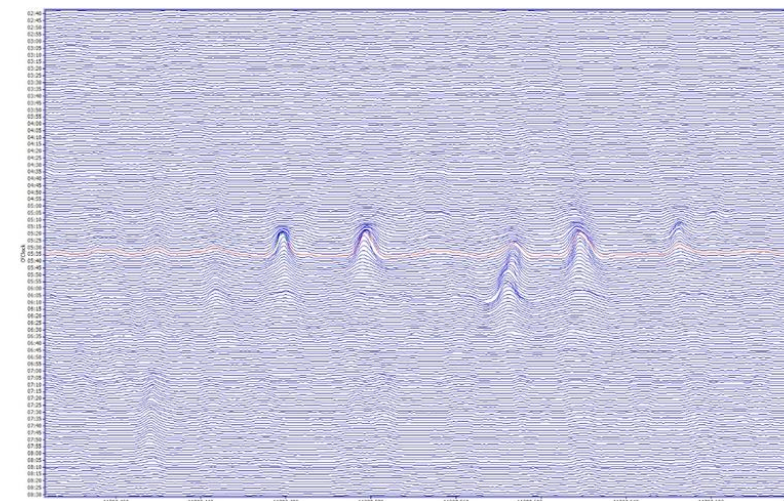
Increased
**sensitivity &
precision**

1029

sensor channels

Ultra High Resolution

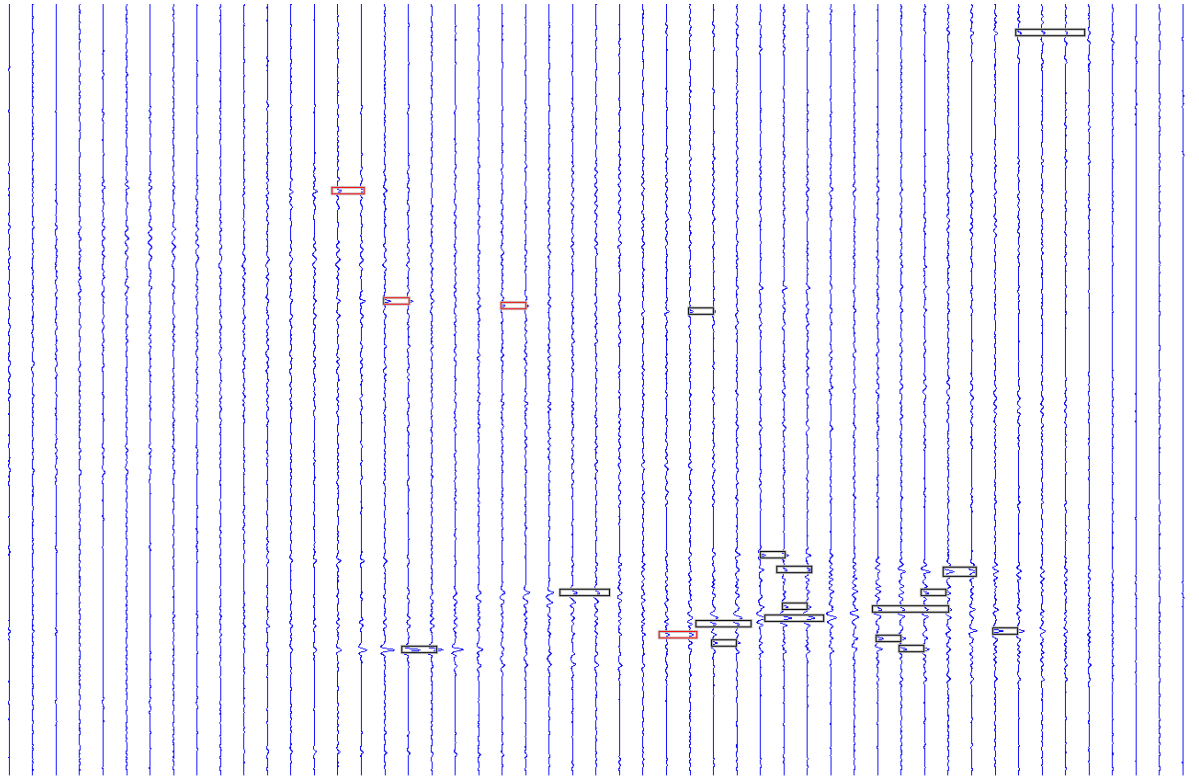
Traditional MFL resolution

Complexities introduced by Ultra High Resolution

Increased number of false calls

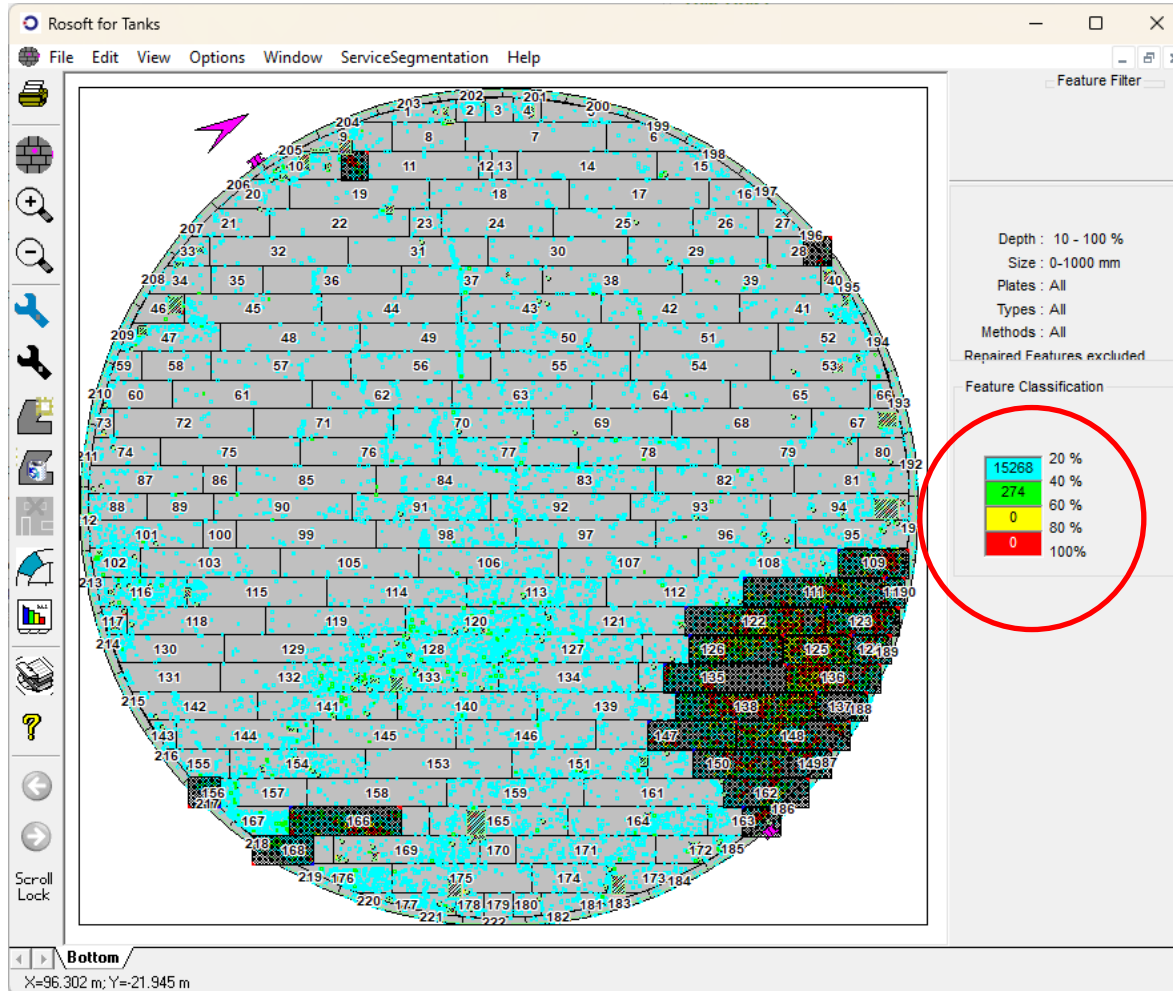
Increased number of indications to be assessed

Inspection results with **traditional** resolution (2019)

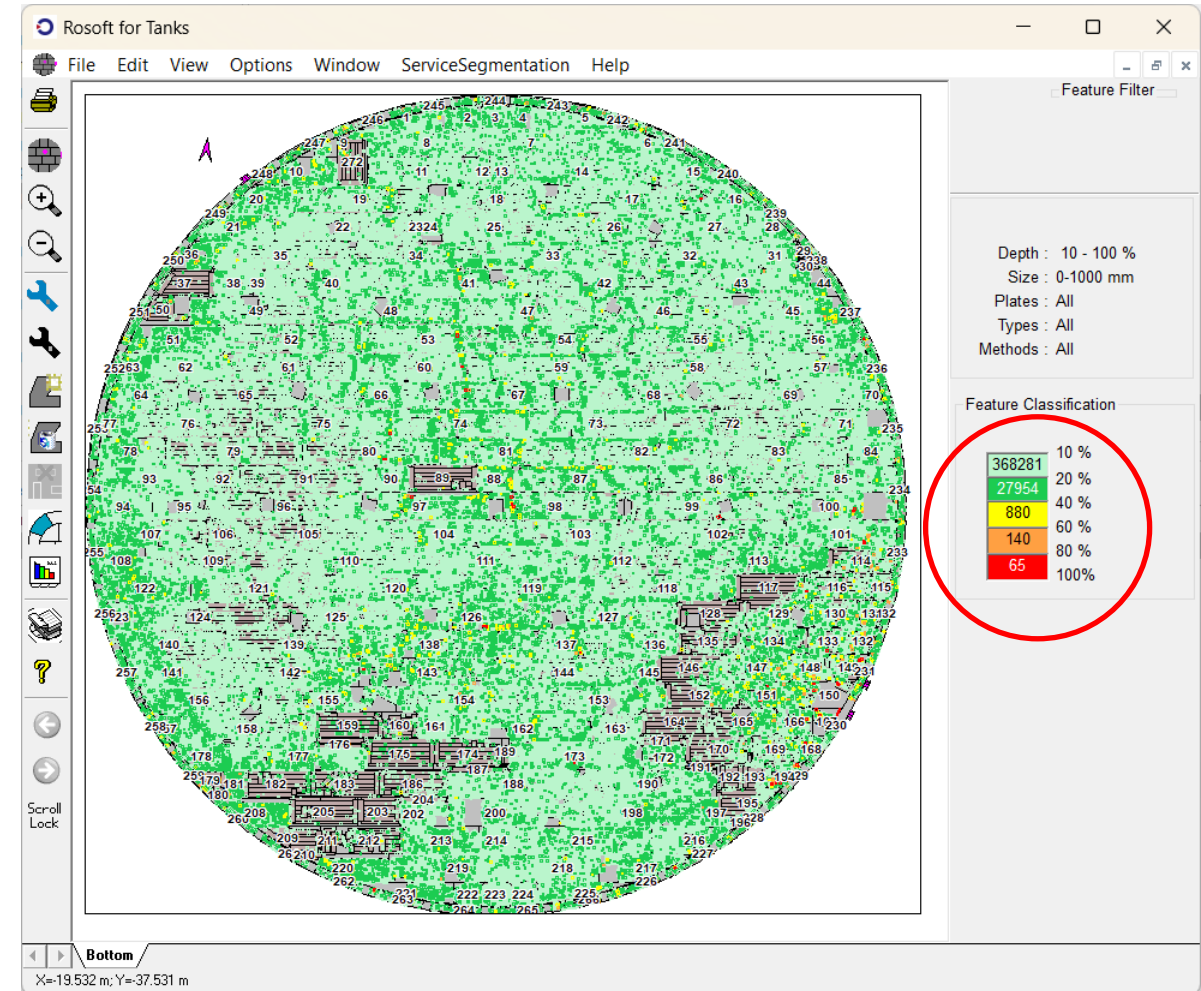
Inspection results with **Ultra** resolution (2024)

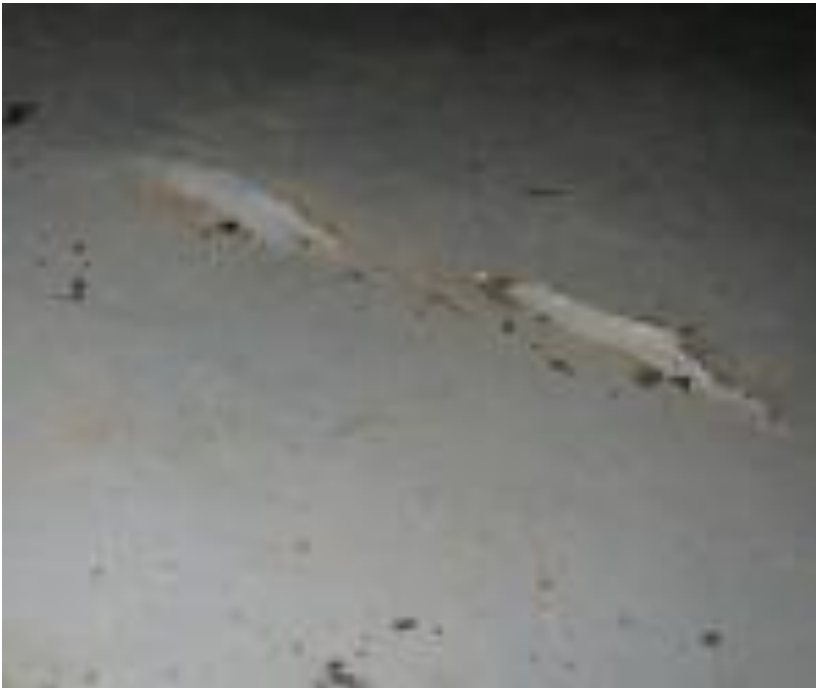
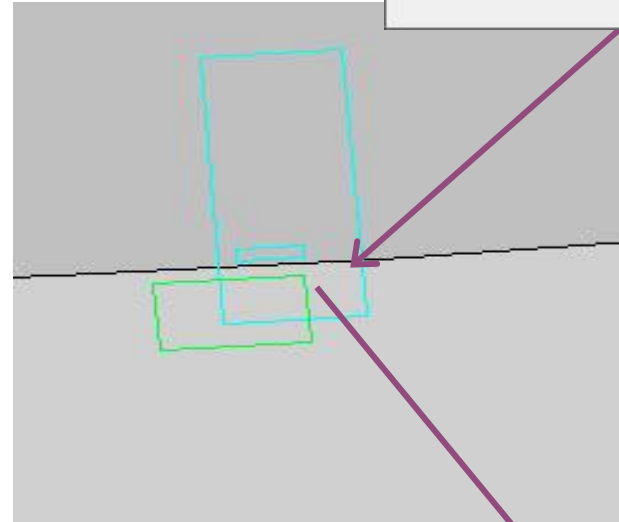
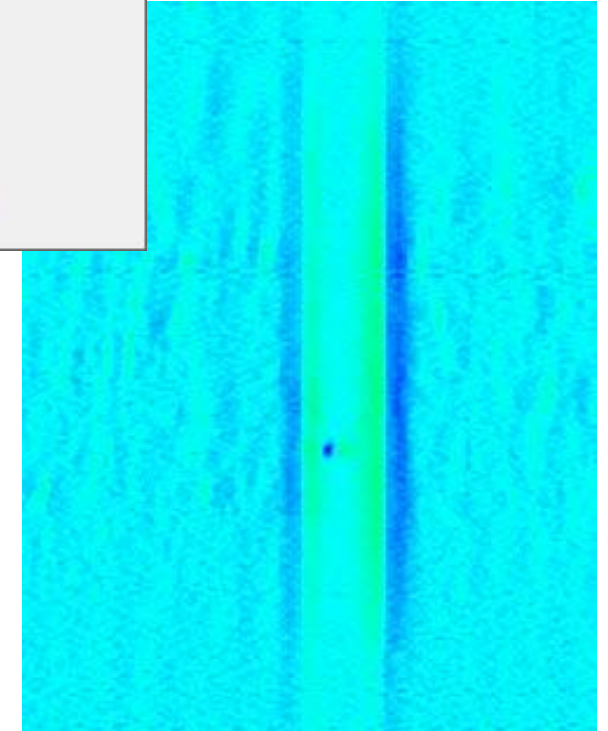
False call example - Tack welds

Tack weld, often left over by welders protrude from the bottom plate usually found near other bottom plate welds.

Tack welds in line plot usually resembles the letter **M**

Inspection Side Feature:
No.: 50.0.156
Tool ID : T56
length = 54 mm
width = 133 mm
depth = 21 %

Method = TBit
Type = Metal Loss

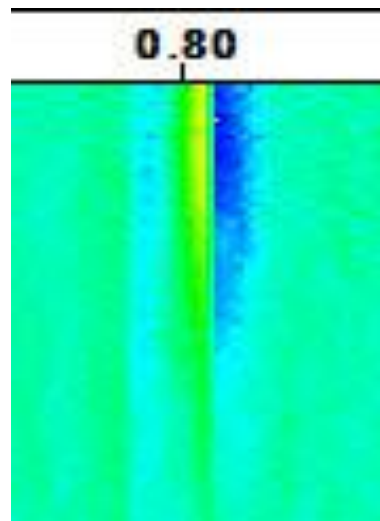
C-Scan

False call example - Settlement

Settlement indication usually appears as a straight line that runs along the width of the line plot.

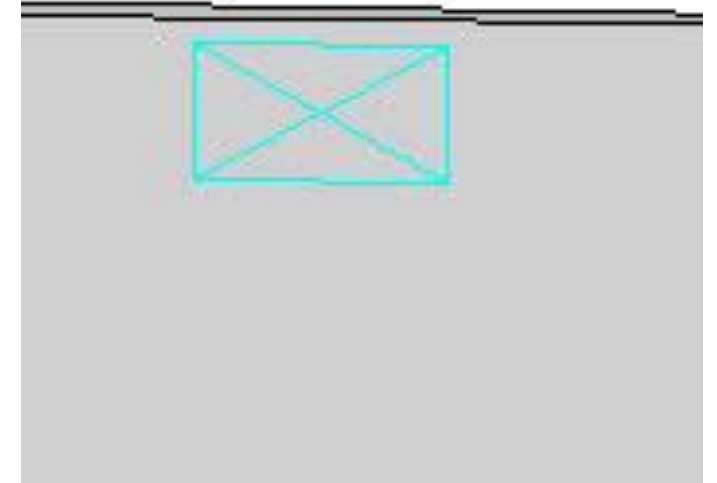
Plate
View

Inspection Side Feature: (disabled)
No.: 51.0.58
Tool ID : T56
length = 65 mm
width = 35 mm
depth = 27 %

Method = TBit
Type = Metal Loss

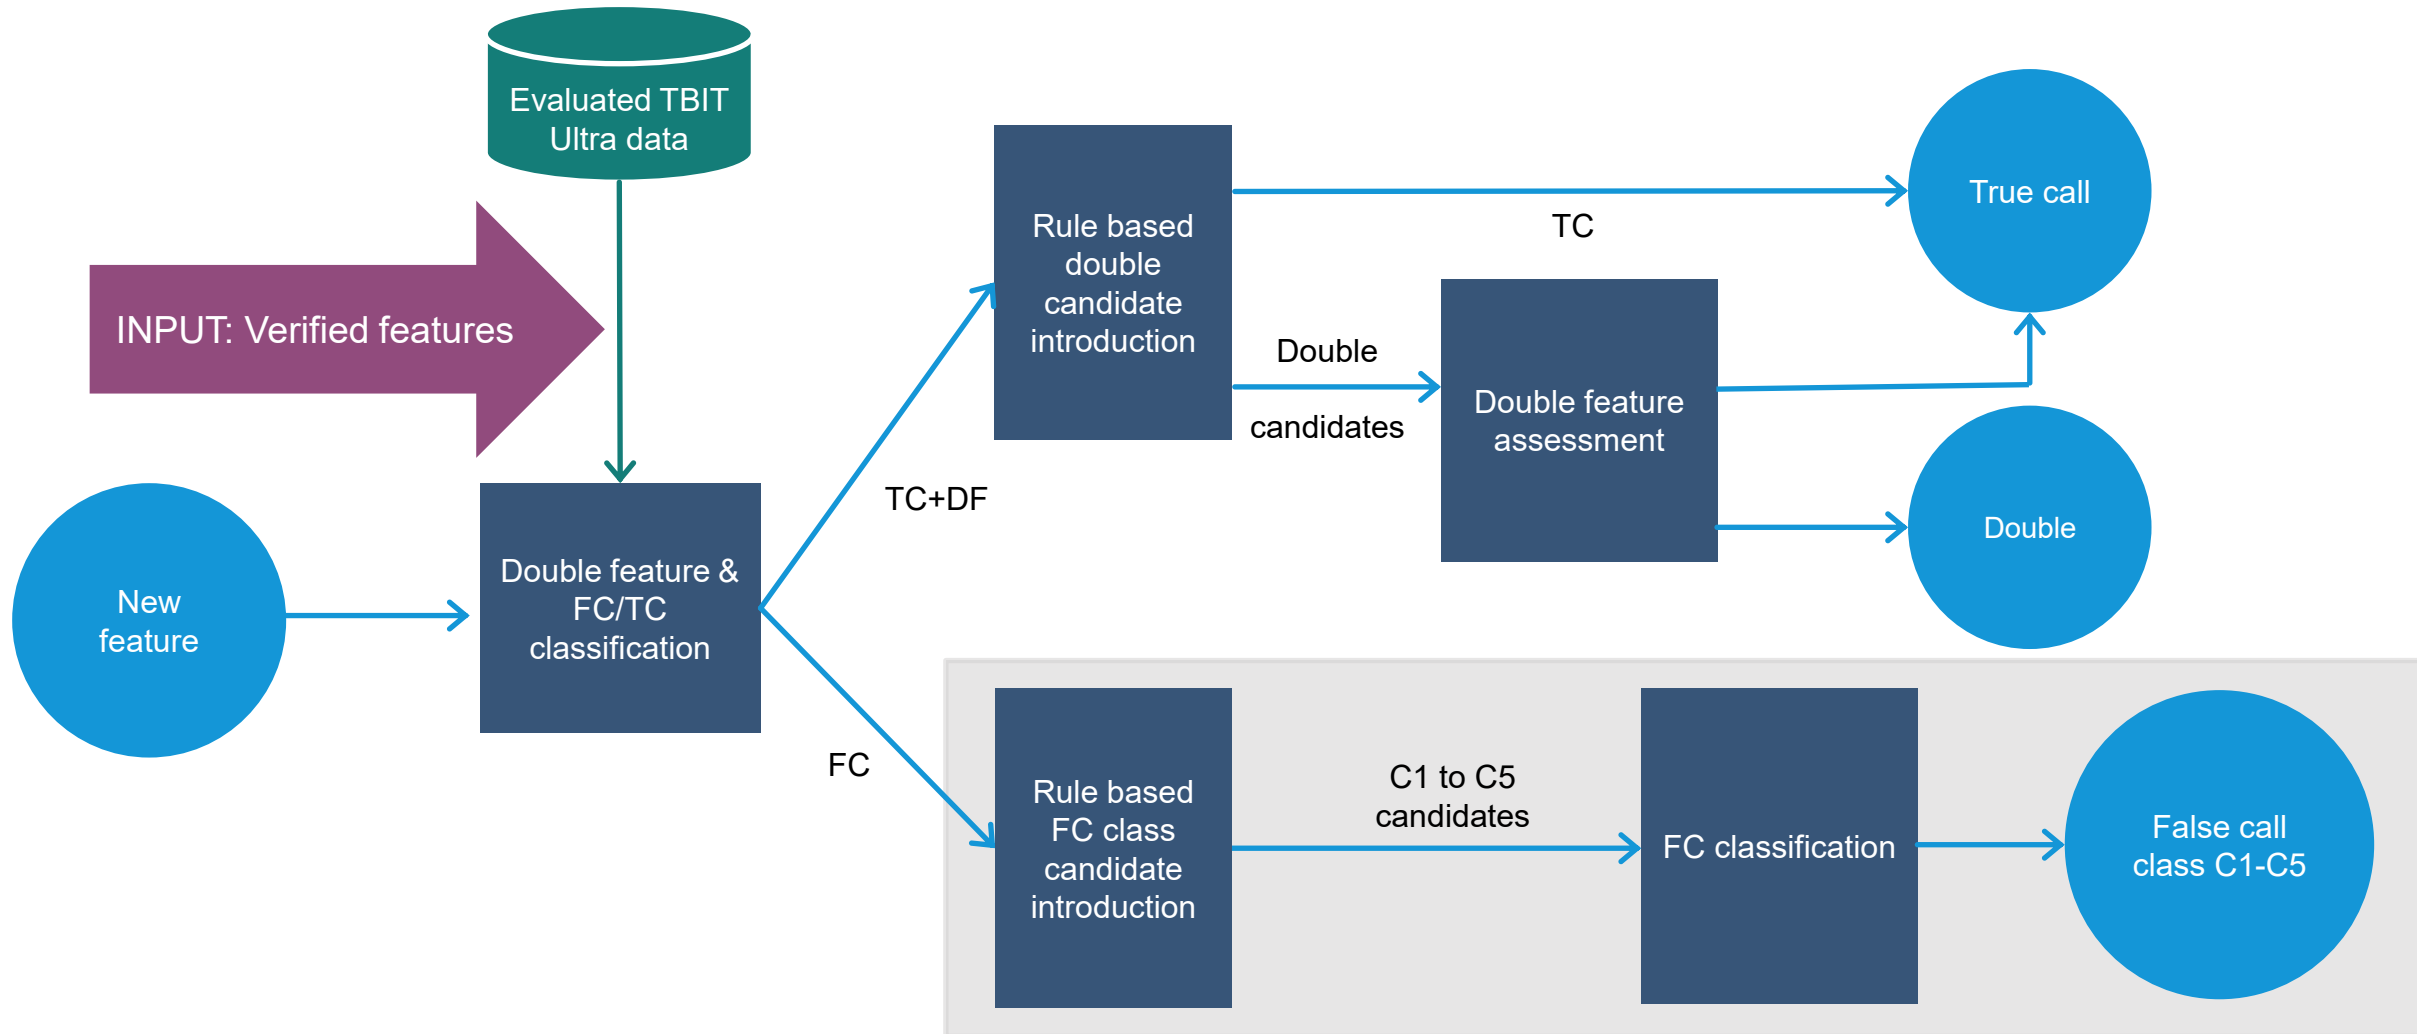
Algorithm for automatic double feature & false call elimination
